CWA Manzanita Erosion Control Project

ADEQ Title 319 Grant

Benson / St. David, Arizona

May 2006 – April 30, 2008

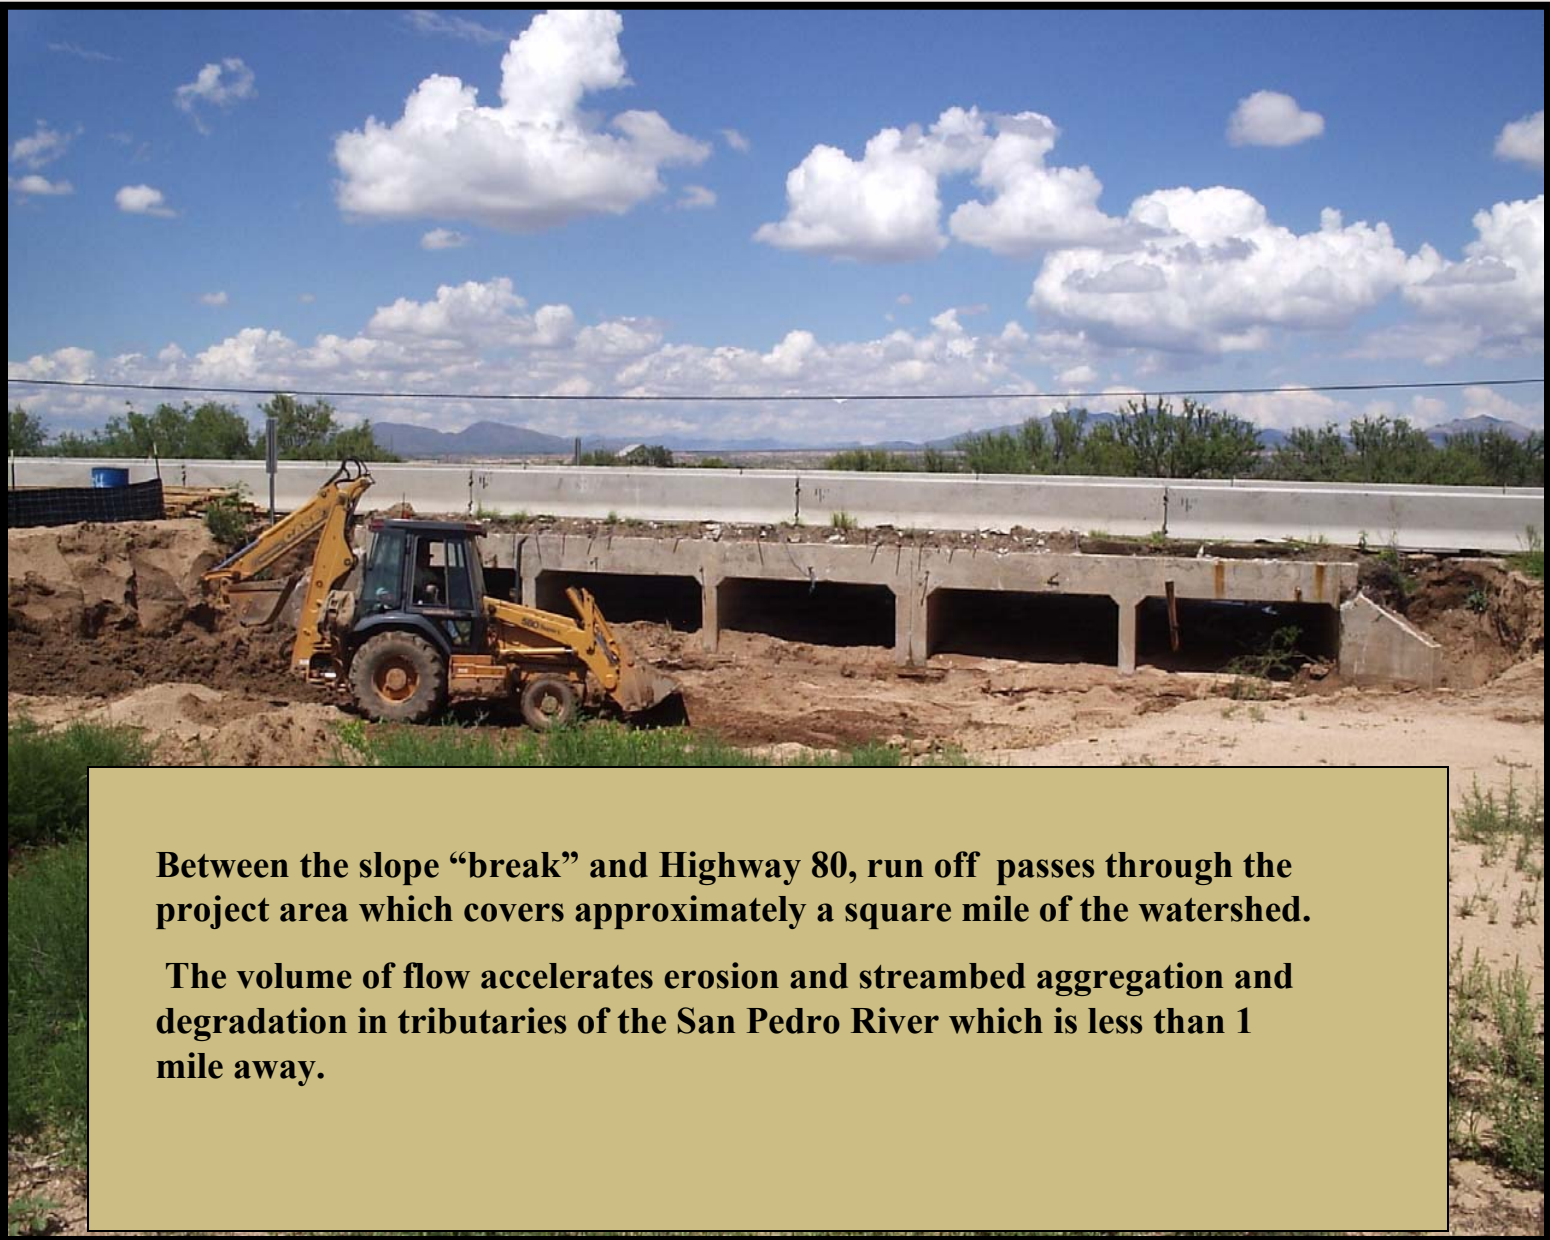
Current flow conditions are from an up slope channel system characterized by steep slopes and deep gullies. The slope breaks just west of the project area where the water is cutting down into deep channels and speeding up. Runoff entering the relatively flat project

area is forming a network of smaller braided channels and new gullies, dropping high volumes of sediment, and ultimately accelerating erosion within the sub-basin downstream to Highway 80.

Between the slope “break” and Highway 80, run off passes through the project area which covers approximately a square mile of the watershed.

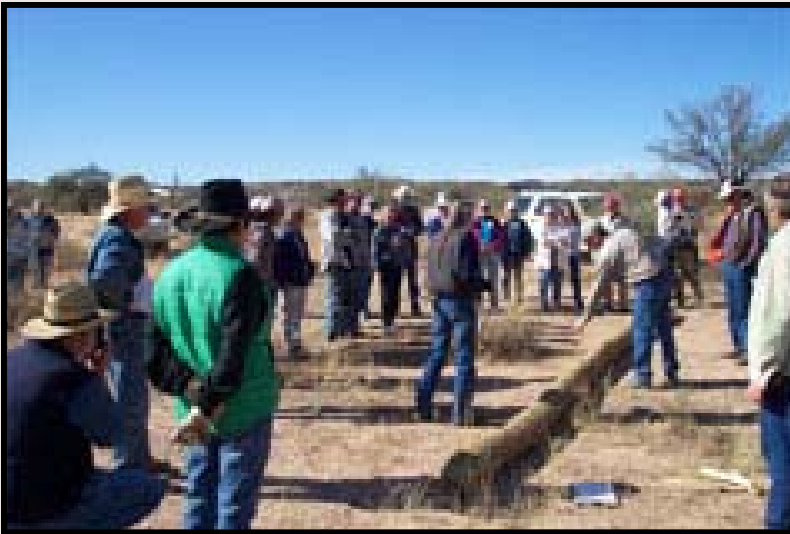
Add network of
check dams to
slow water and
capture sediment.

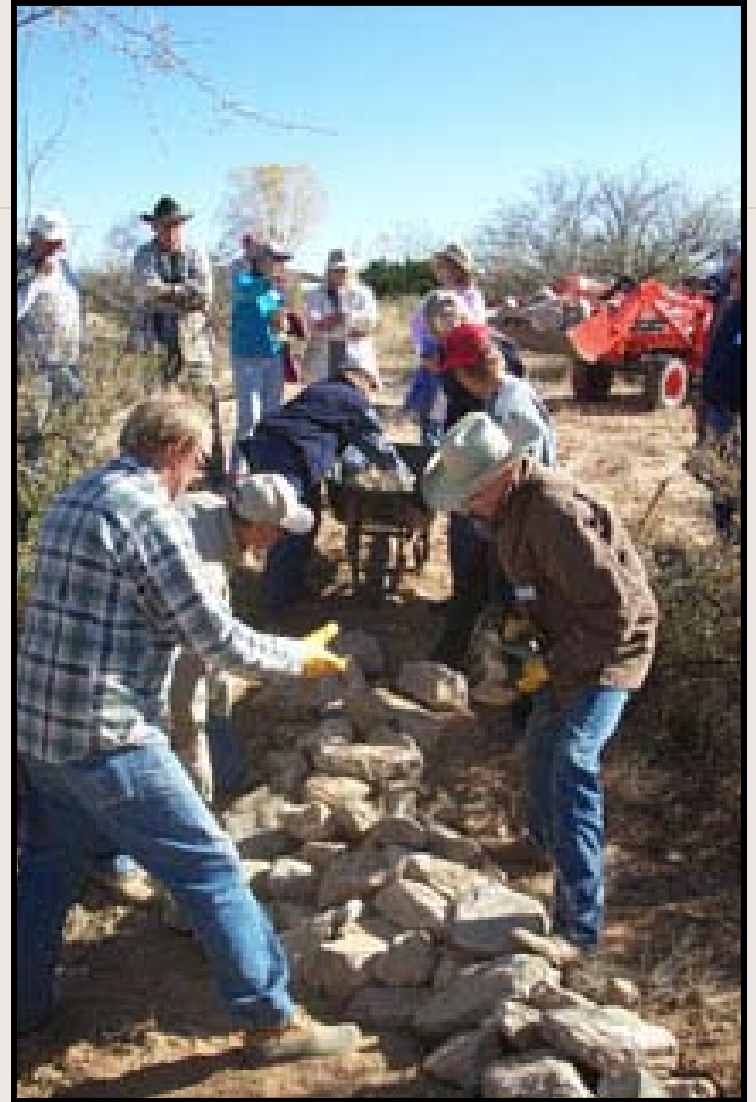
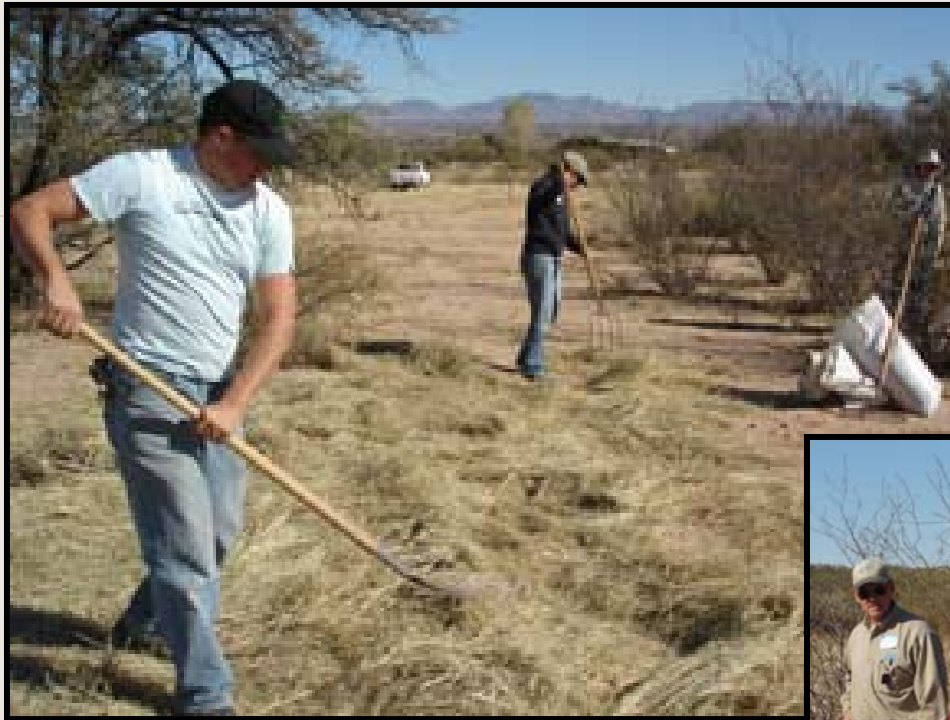
Hands-on Training

Three front end loaders, 34
people, 24 tons of rock

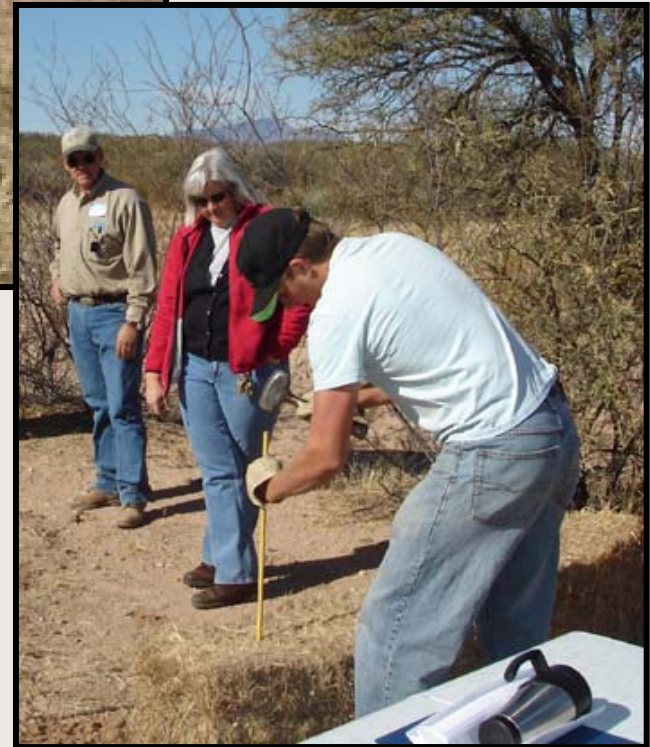
Restore ground cover by
reseeding where
appropriate

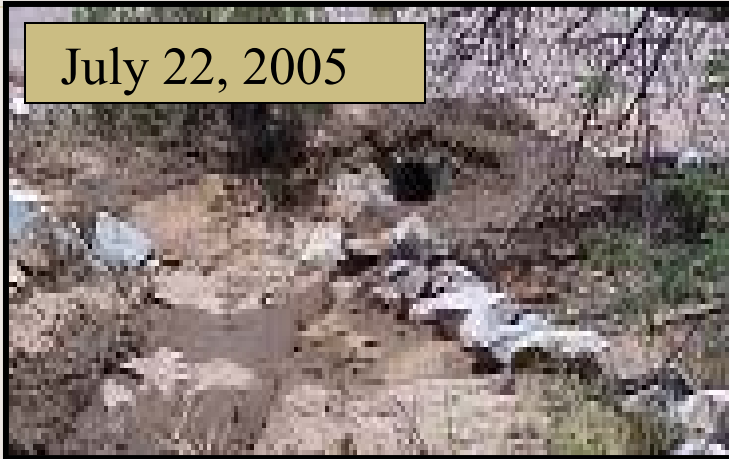
July 22, 2005

Size culvert to prevent undermining of structure and bank destabilization.

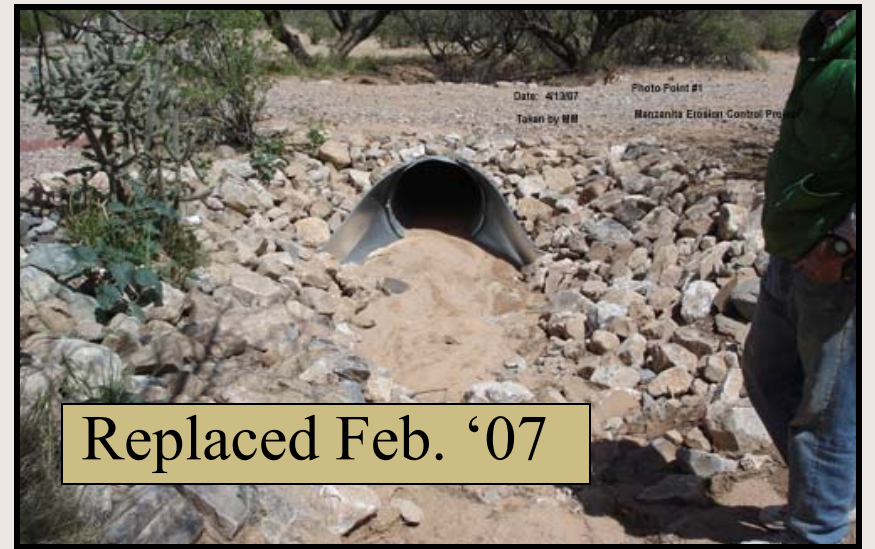
Replaced Feb. '07

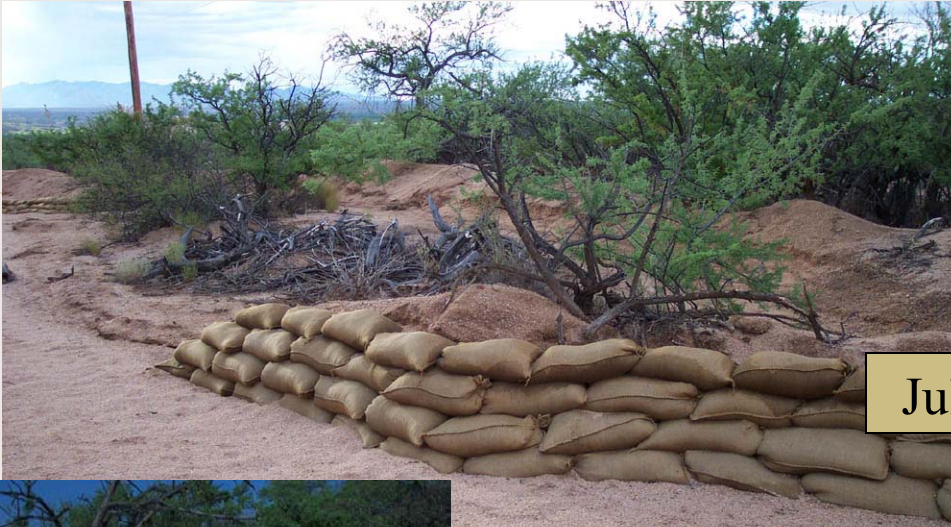
**Add permanent
bank stabilization**

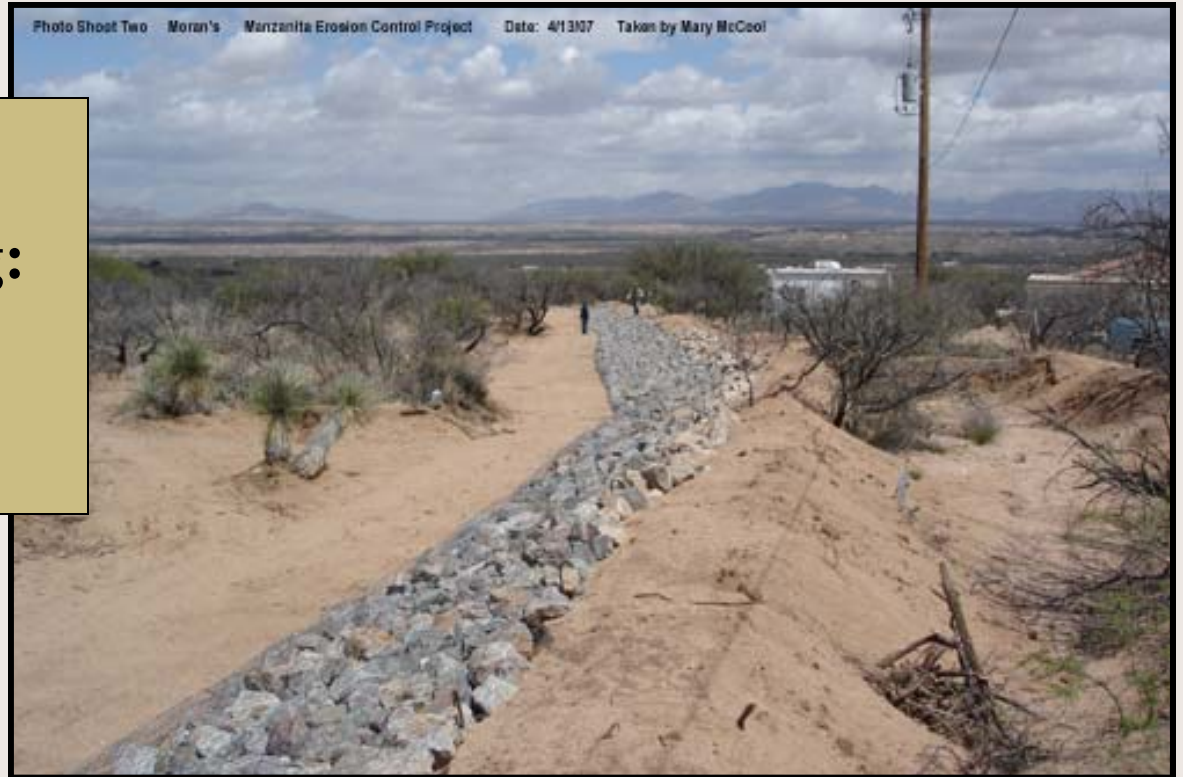
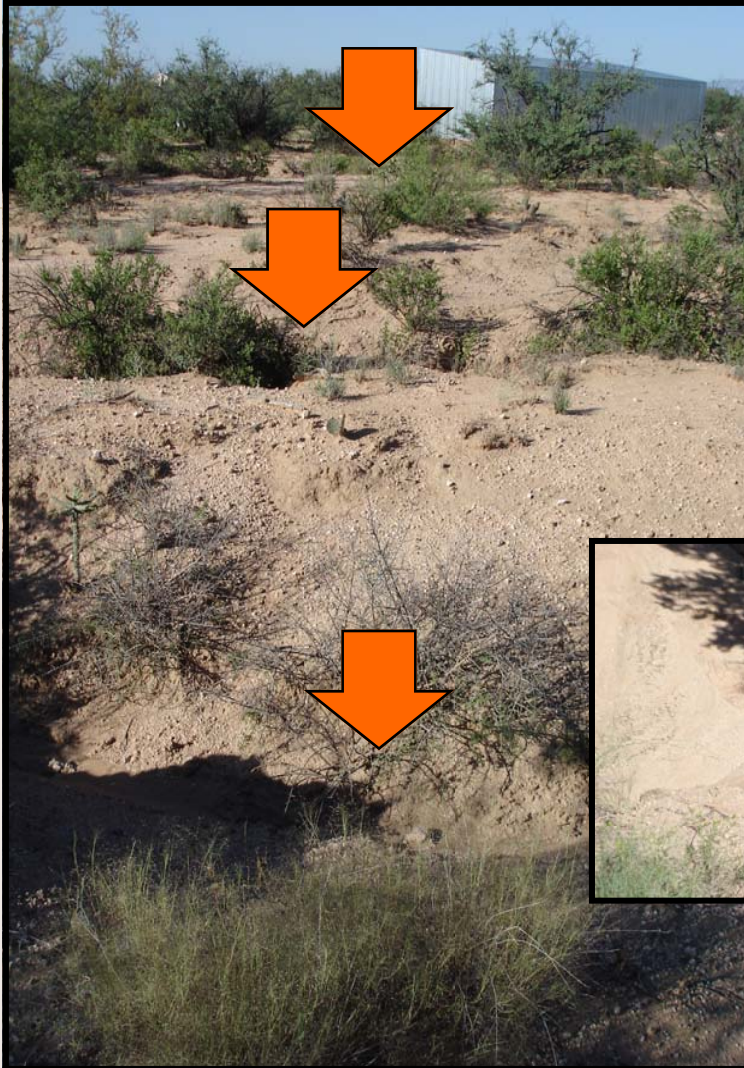
**Photo
Monitoring:
412 feet
Dec. '07**

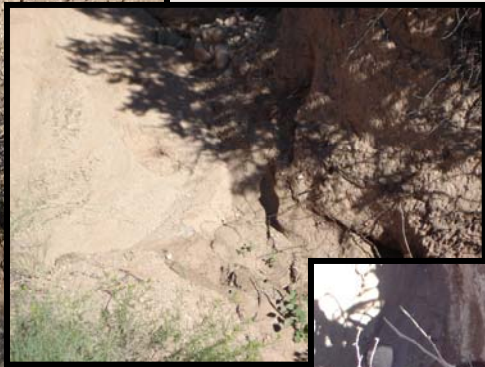
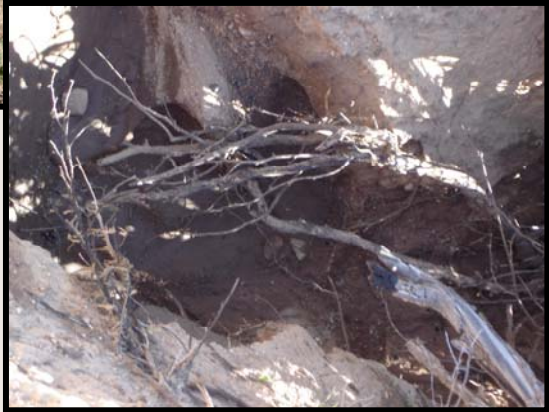
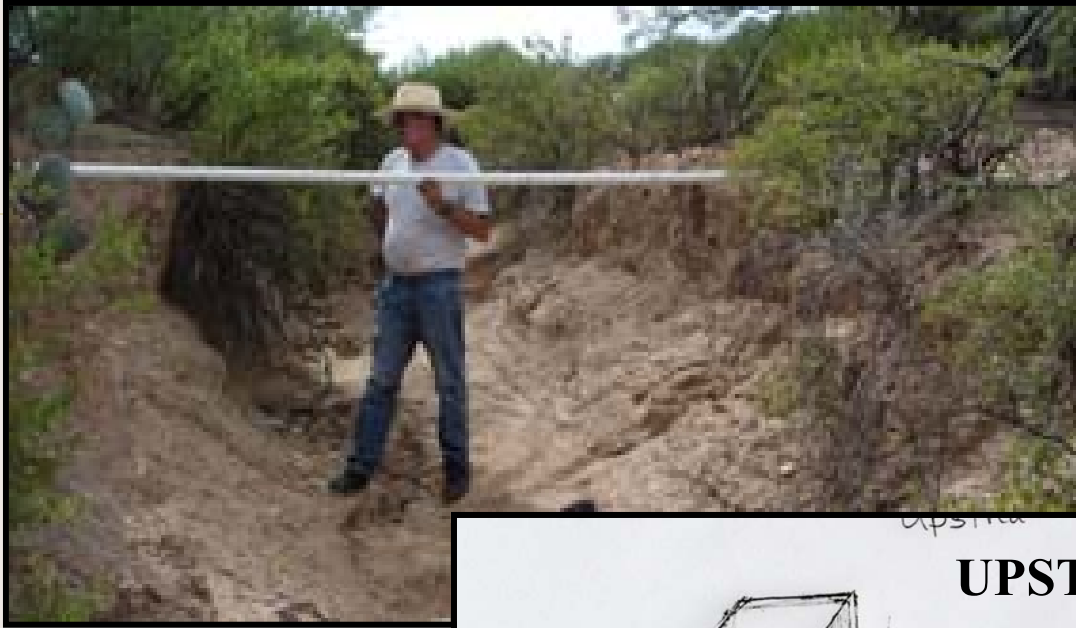
Aug. 2005

**CONSTRUCT
GULLY PLUGS**
to arrest headcutting
