CWA Manzanita Erosion Control Project

Benson / St. David, Arizona

May 2006 – January 2009

PHOTO GALLERY REVIEW

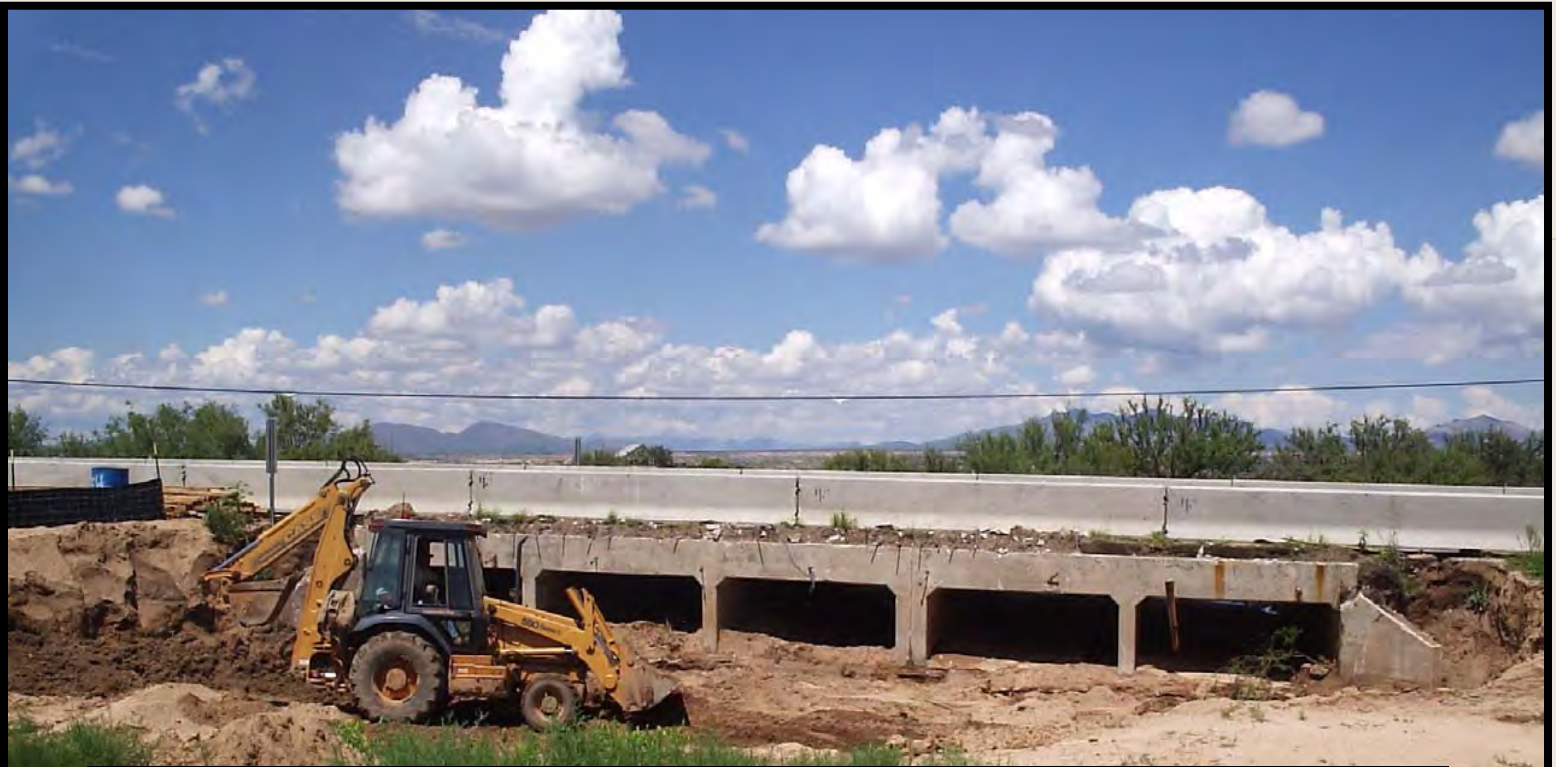
WATER QUALITY ISSUE

Current flow conditions are from an up slope channel system characterized by steep slopes and deep gullies. The slope breaks just west of the project area where the water is cutting down into deep channels and speeding up. Runoff entering the relatively flat project

area is forming a network of smaller braided channels and new gullies, dropping high volumes of sediment, and ultimately accelerating erosion within the sub-basin downstream to Highway 80.

Between the slope “break” and Highway 80, run off passes through the project area which covers approximately a square mile of the watershed.

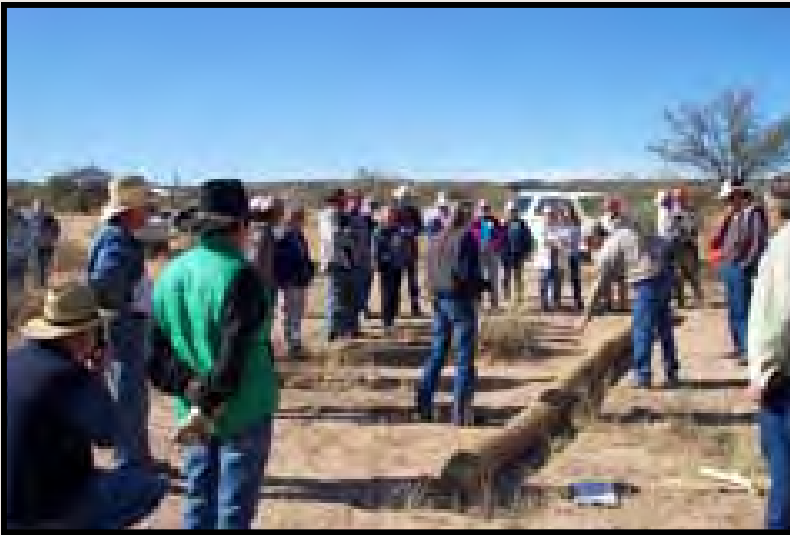
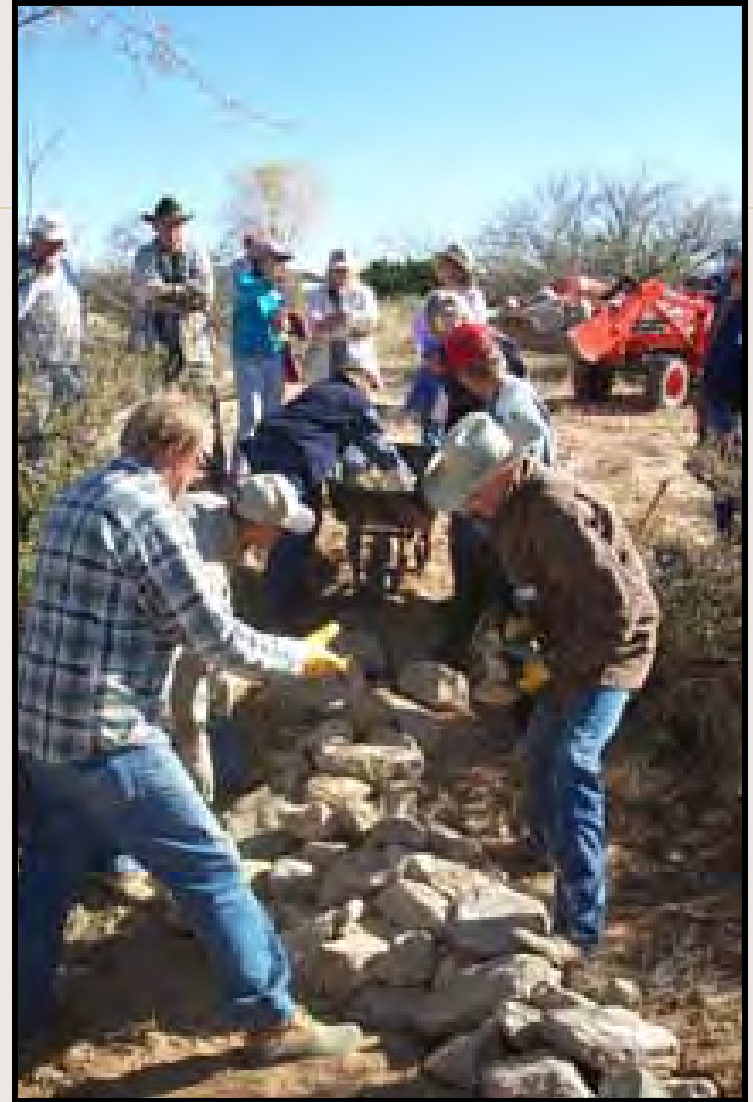
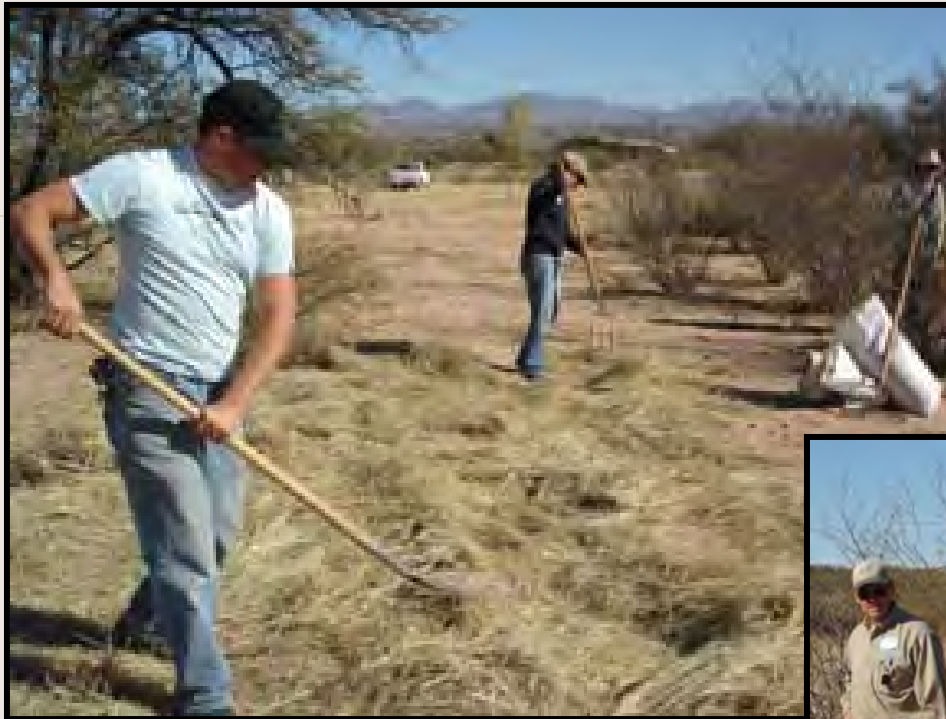
**I. Add network
of check dams to
slow water and
capture sediment.**

Hands-on Training

Dec. 2007

Three front end loaders, 34
people, 24 tons of rock

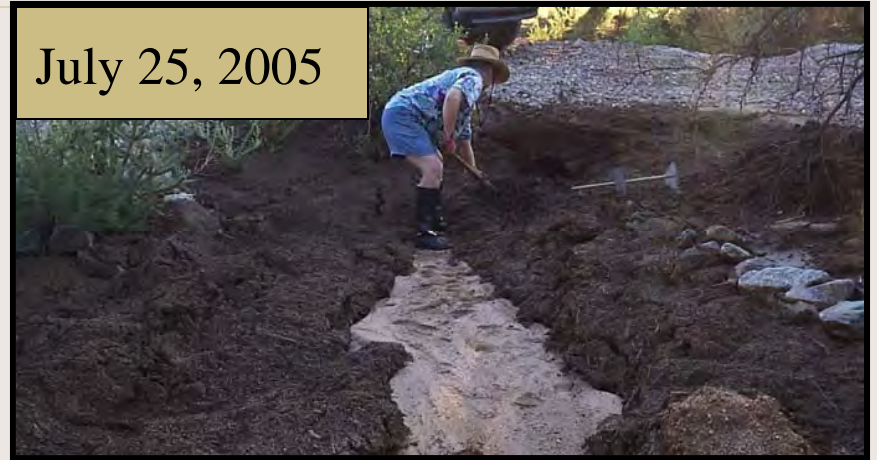
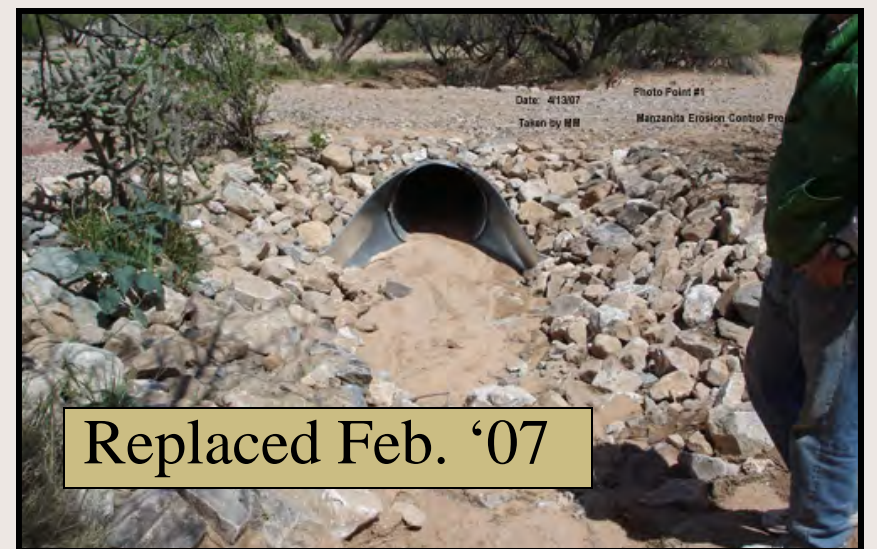
III. Size culvert to prevent undermining of structure and bank destabilization.

July 22, 2005

July 25, 2005

August 10, 2005

Replaced Feb. '07

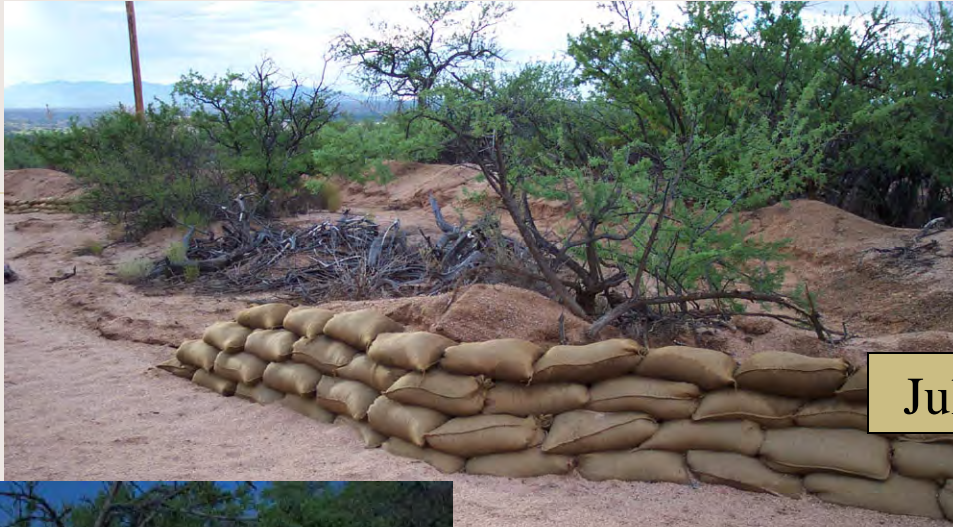
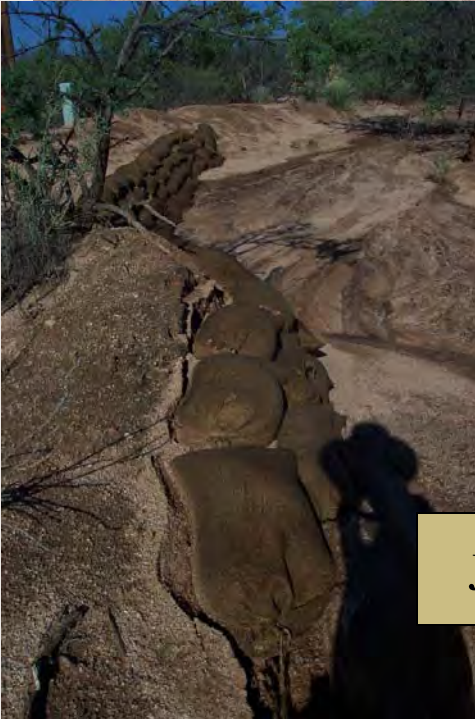
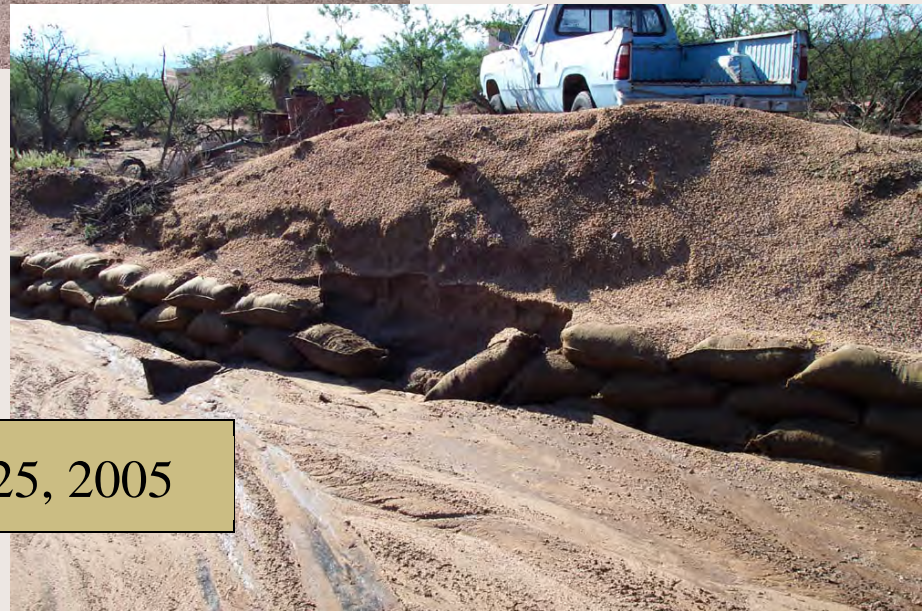
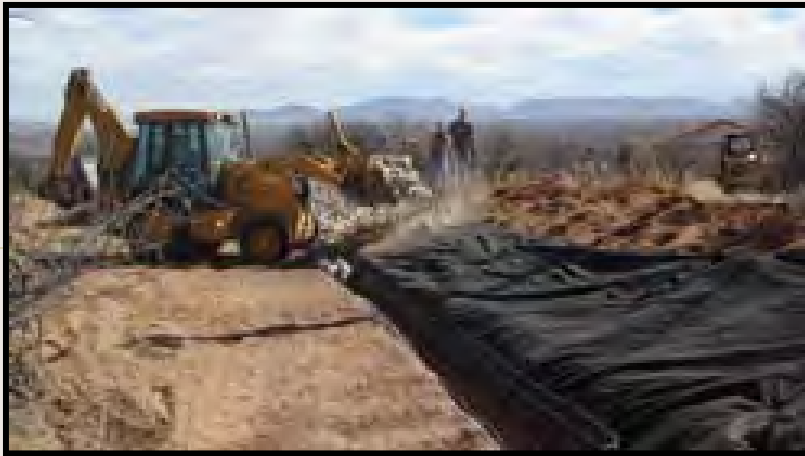
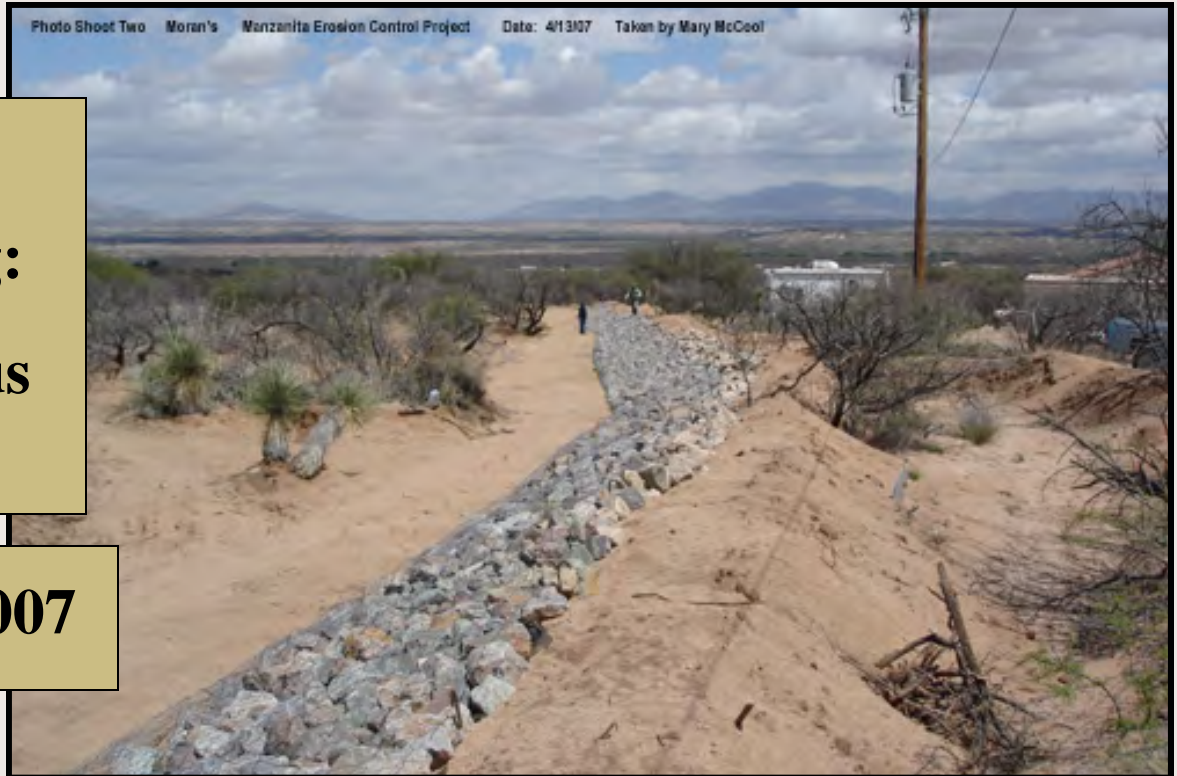
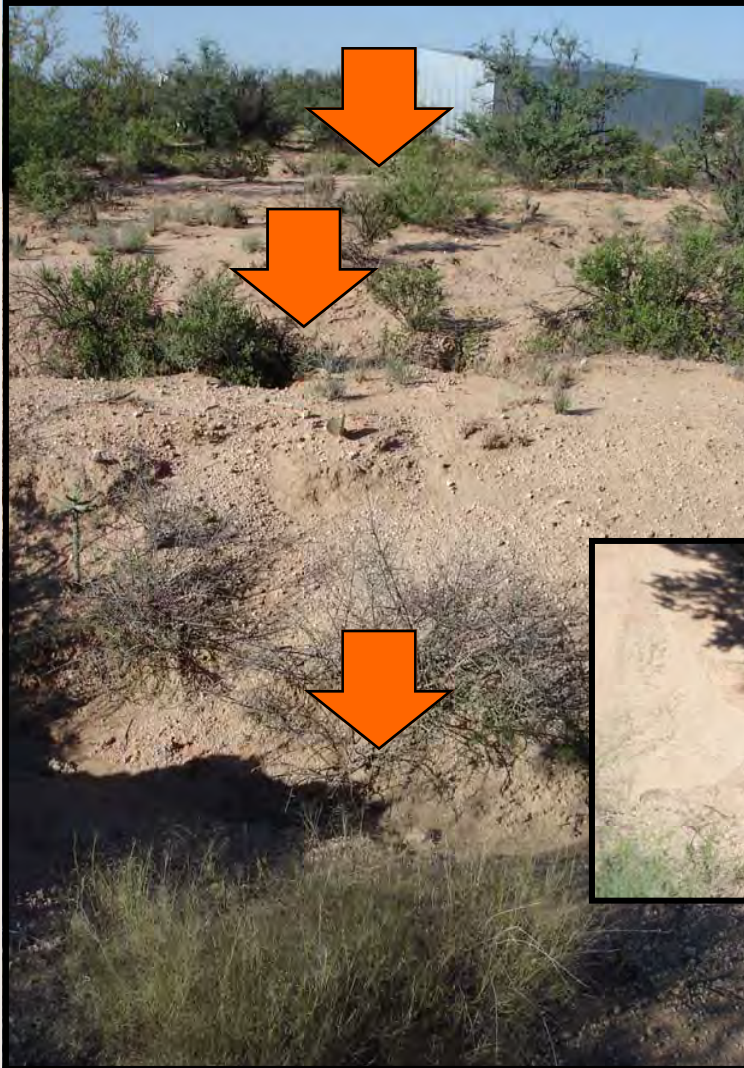
**IV. Add
permanent bank
stabilization**

July 22, 2005

July 25, 2005

**Photo
Monitoring:
412 feet plus
Dec. '07**

February 2007

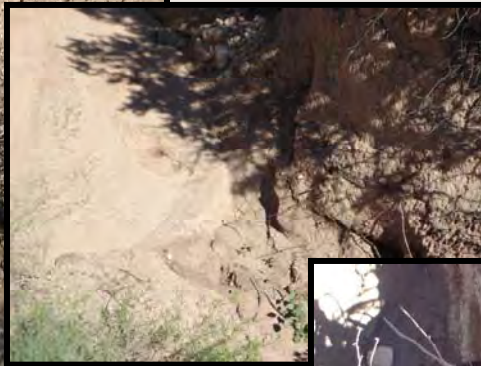
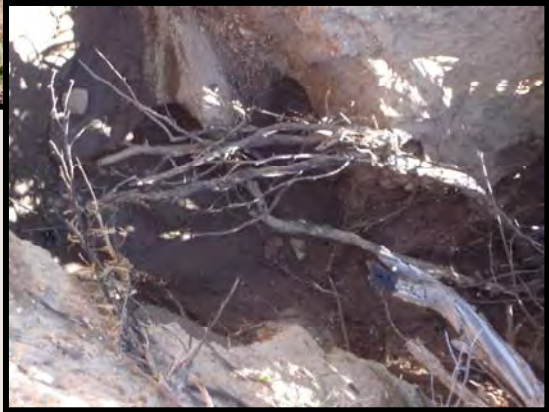
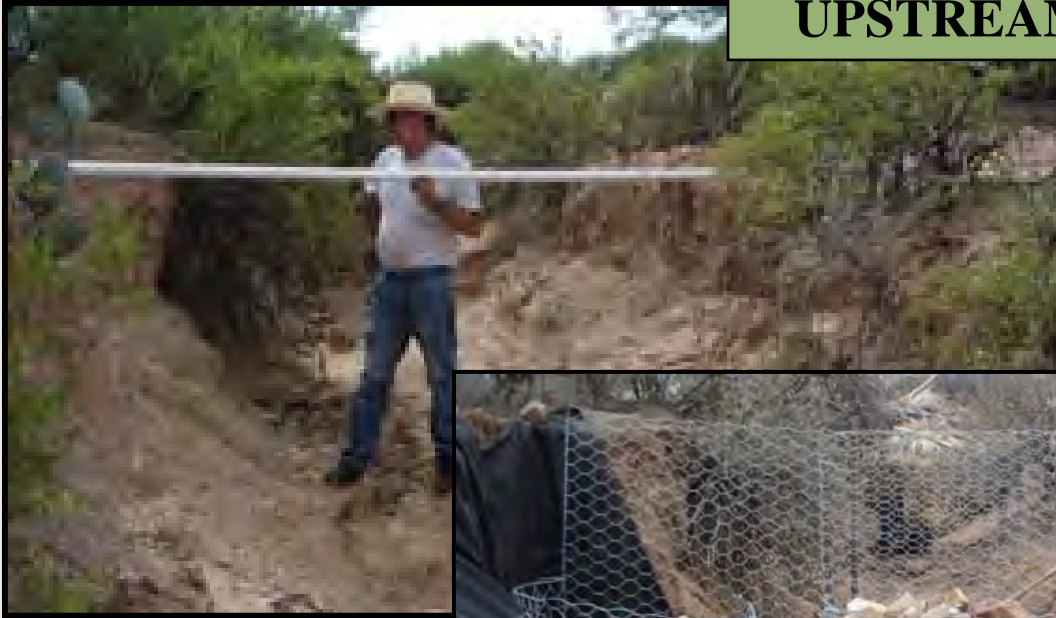
**VI. CONSTRUCT
GULLY PLUGS
to arrest headcutting**

Aug. 2005

UPSTREAM

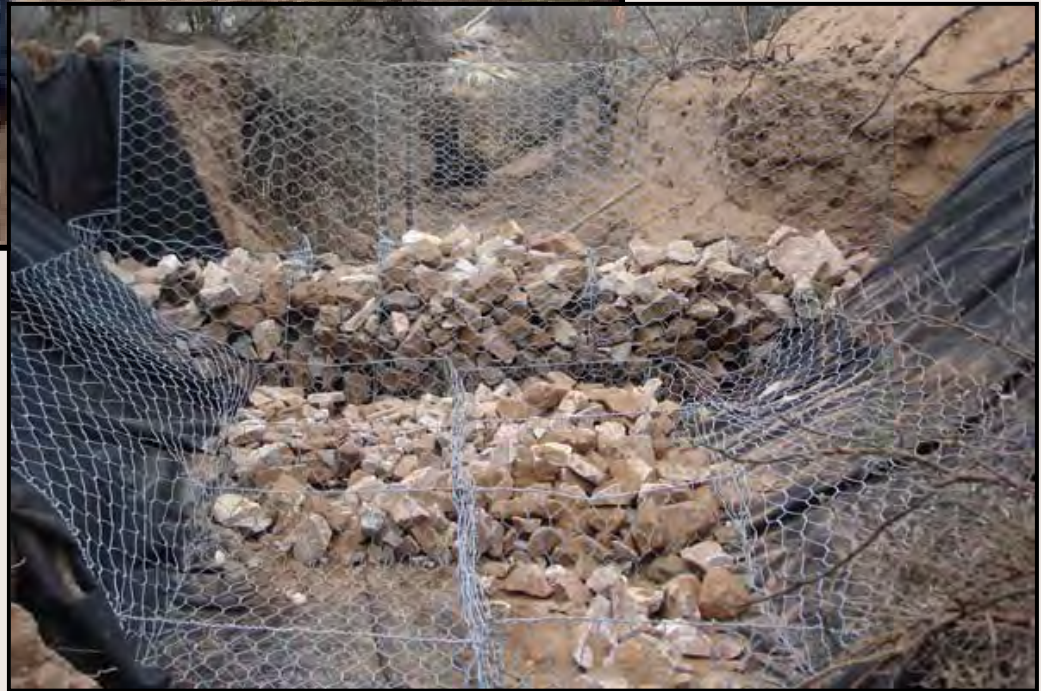
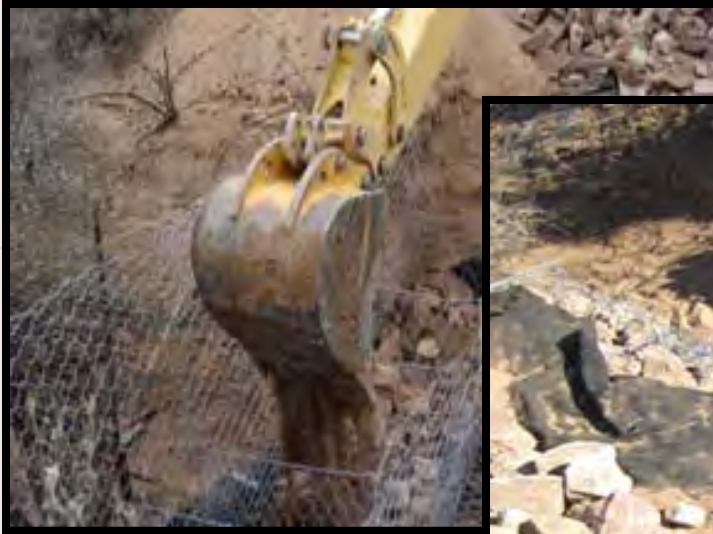
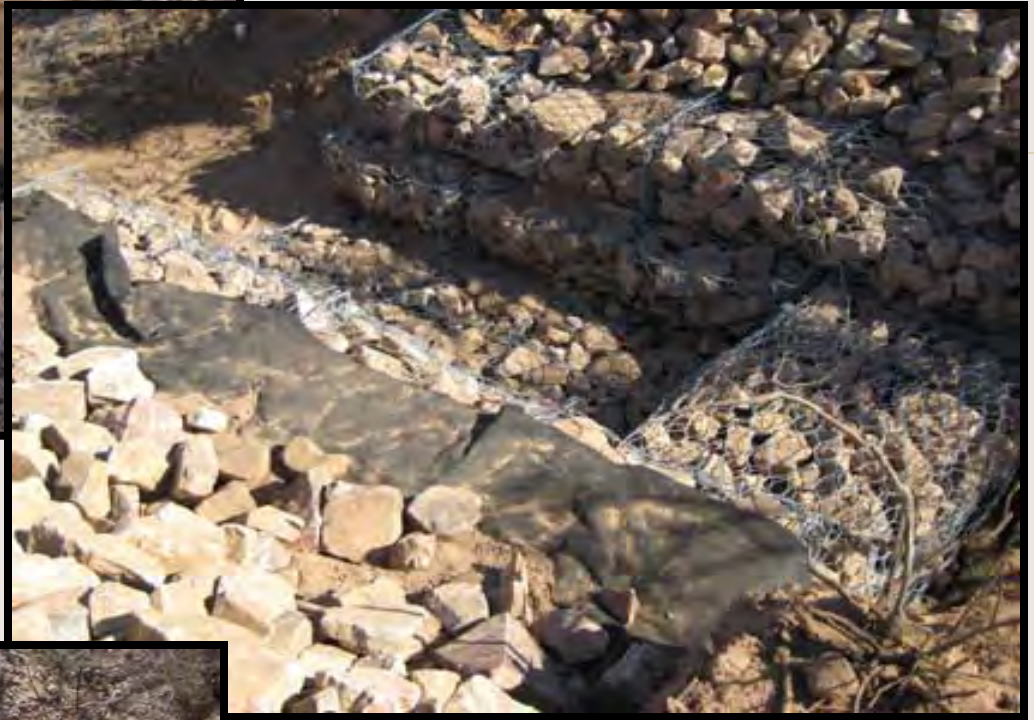
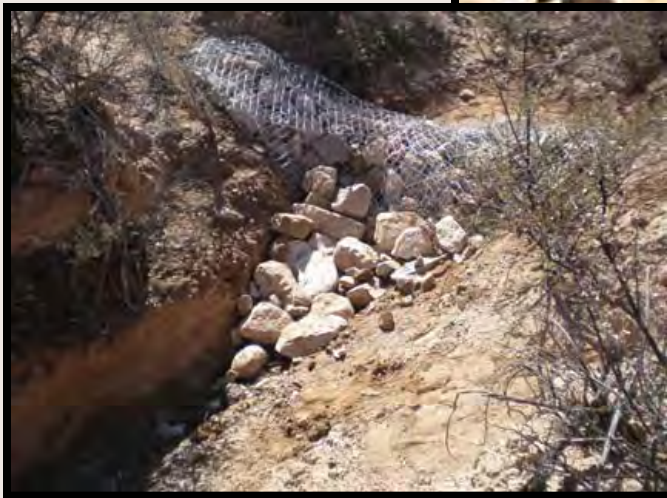
**Gabion Baskets and
Wire Sausages to
arrest headcutting**

**DETAILS IN
GABION
WORKSHOP
POWERPOINT**

Feb. 2008

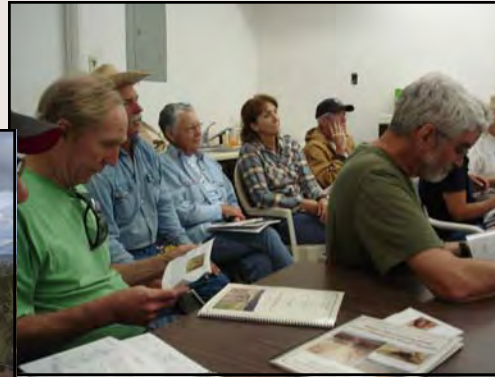
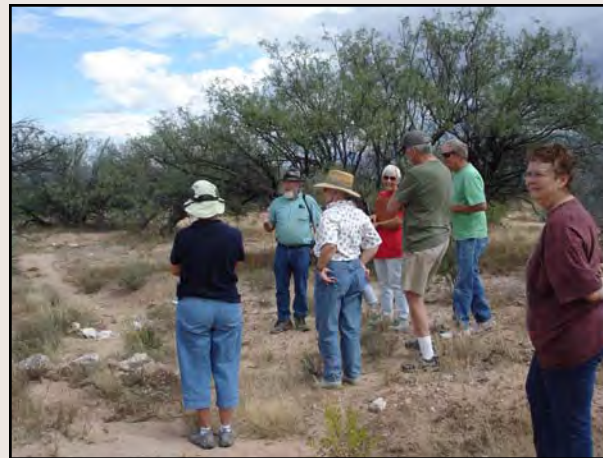
Participants had an opportunity to develop a management plan for two different sites, identifying key opportunities for rolling dips and multiple lead out ditches based upon slope, soil type, and adjacent vegetation.
