SUMMARY REPORT ON CONSTRUCTION AND MAINTENANCE OF RURAL ROADS WORKSHOP - OCTOBER 11, 2008

(Funded by a grant from the United States Environmental Protection Agency and the Arizona Department of Environmental Quality)

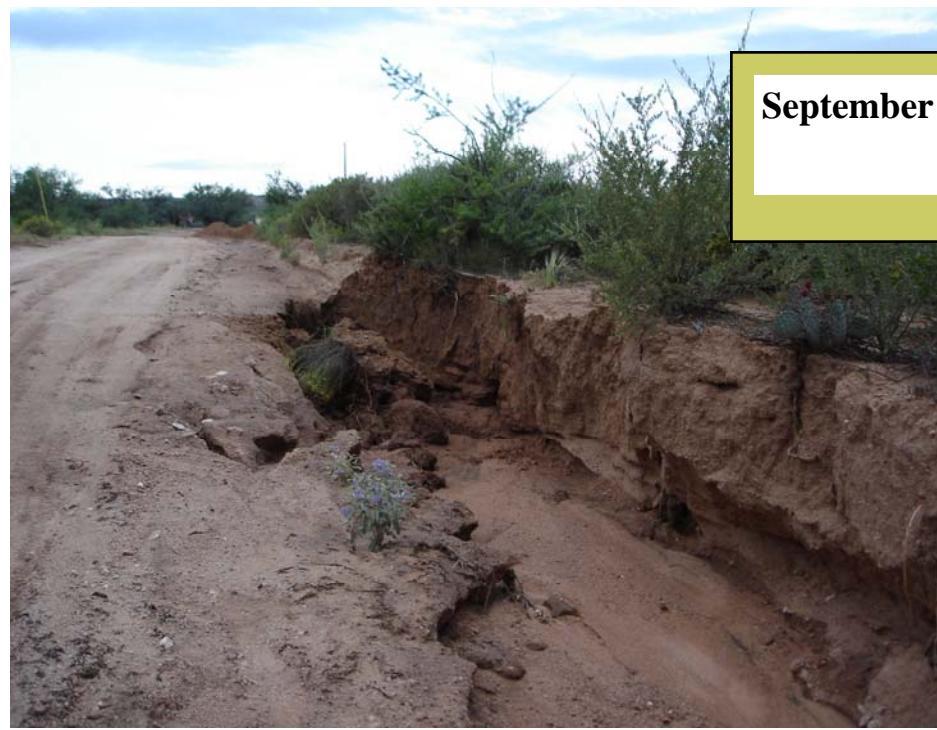
August 22, 2005 occurred after uproad action taken and first 9/10" rain event.

September 9th, 2005—bank collapsed.

Project Site Four includes implementing new road blading strategies and neighborhood network to prevent practices impacting adjacent properties.

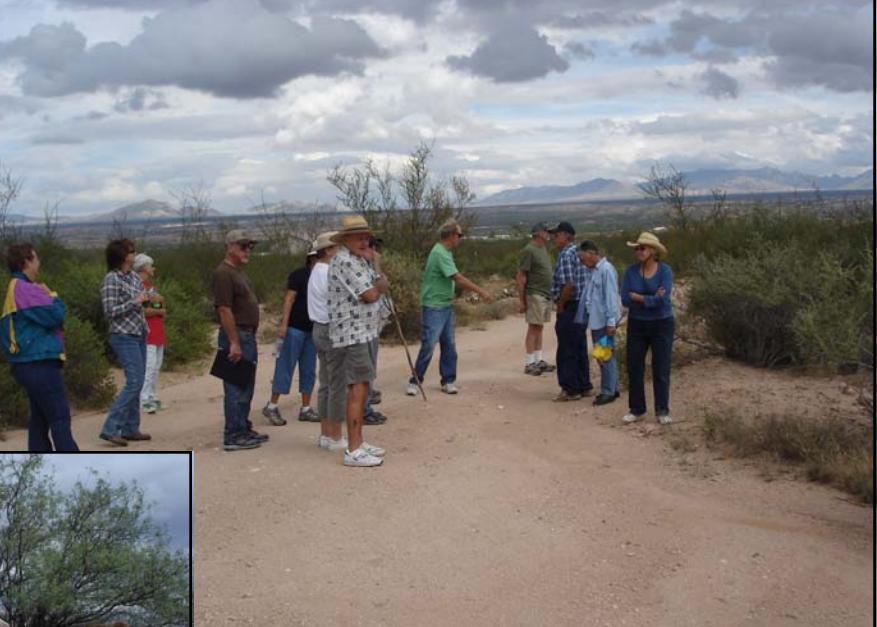
Participants had an opportunity to develop a management plan for two different sites, identifying key opportunities for rolling dips and multiple lead out ditches based upon slope, soil type, and adjacent vegetation.

Participants armed with manuals, umbrella's and make shift raincoats, headed to the project area for an additional two hours plus. By starting at the top of the drainage, Bill identified numerous opportunities for rolling dips, placement of multiple lead out ditches, slope changes, and ditch management that would effectively drain the roads and supply water to adjacent vegetation.

With the weather holding, participants were able to practice the pragmatic approach of identifying the "first change, last chance, best chance, and no chance" in selecting drainage points based upon steepness of road grade and soil texture as related to erodability of the road surface.
